LLANLLECHID

Conservation Area Appraisal and Management Plan

Chambers Conservation Ltd,

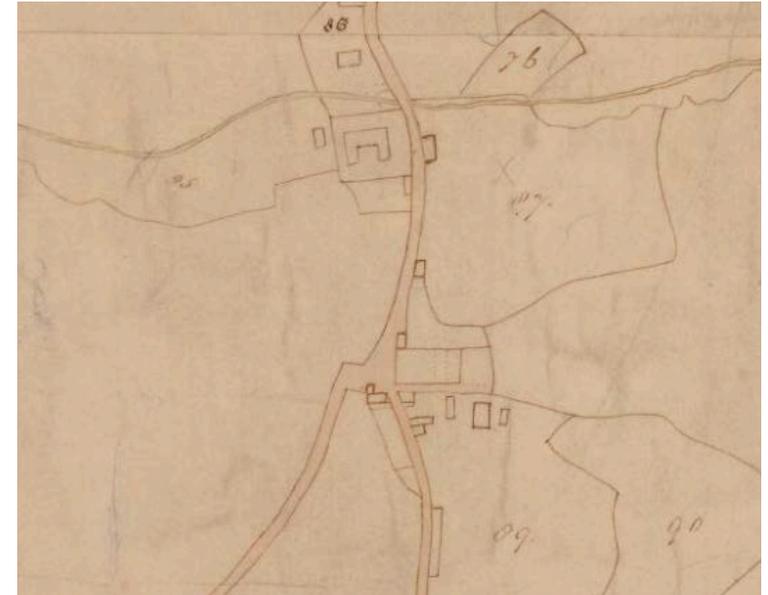
06 Tithe Map, 1839, note the earlier church in a 'U' shape.

3.1.6 The medieval church was described as a 'long, low ancient edifice consisting of a nave and chancel, with a small chapel or oratory on the south side.⁸ A terrier of 1831 recorded the dimensions of the former medieval church as 49ft long and 48ft wide for the nave, and 20ft 3in long and 48ft wide for the chancel.⁹ The chapel was 15ft by 15ft 10in wide. The church had a stone flagged floor and held 214 worshippers.³ An extension was built on the south side at the west end, used as a school room, and this gave the plan of the church a 'U' shape, as shown on the Tithe Map of 1839.

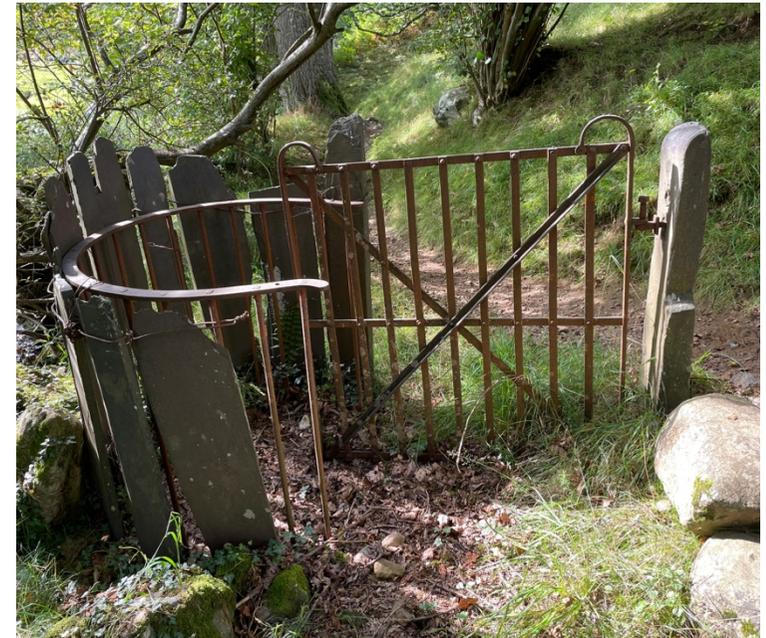
16 Characterful Giat mochyn in the dell behind the church. (2021).

- 4.3.2 The agricultural setting of the church is important to the character, having evidence of earlier agricultural working and providing a rewarding setting for the church. The dell below the church, now part of the Llwybr Llechi Eryri, is a delightful tree lined path of cascading water and glimpsed views both to St. Llechid's and the wider landscape beyond. The gate at the edge of the conservation area is locally forged and riveted kissing gate (giat mochyn) of late 19th century date.

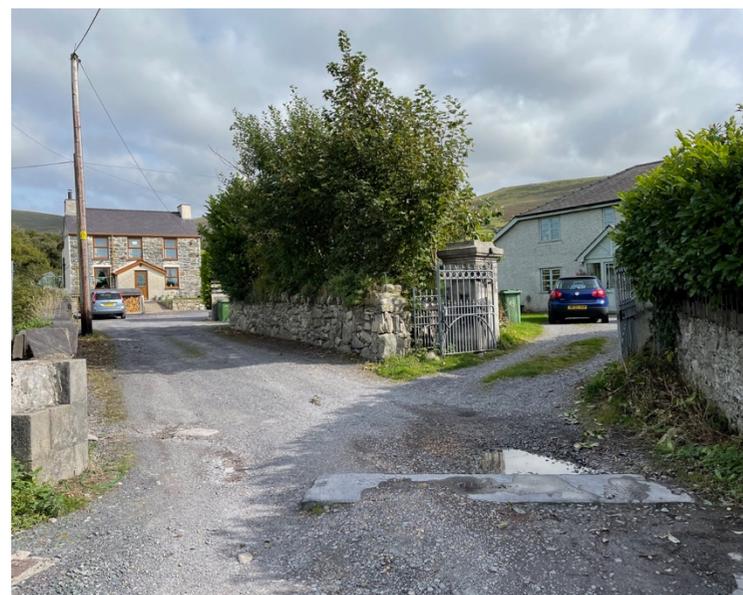
21 Gates and piers from the Calvinistic Methodist Chapel (relocated), the stone threshold and pier shows original location. Ty Capel beyond. (2021)

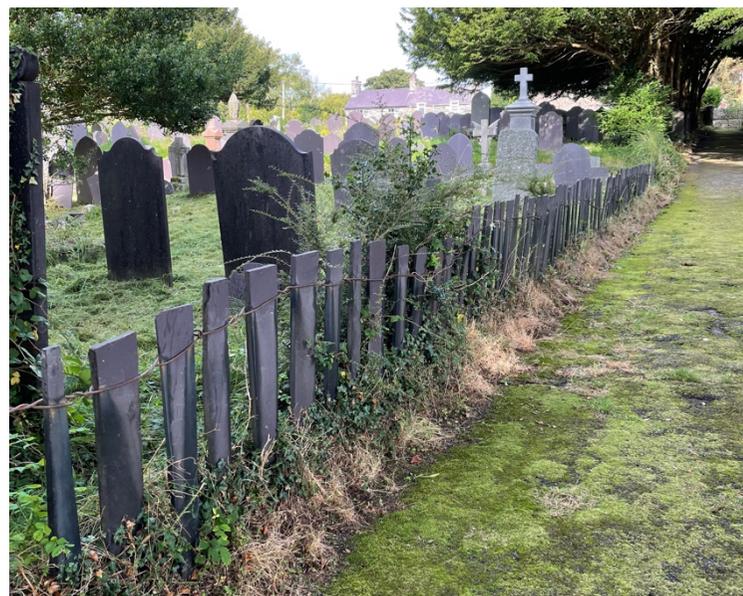
23 Slate fencing in the churchyard (2021)

- 5.4.3 Part of the field north of 1 Tyn Llan has been enclosed by slate fencing, probably of recent date, but a positive contribution to the character of the approach. An earlier fence lines part of the path to the church, beyond the yew avenue.

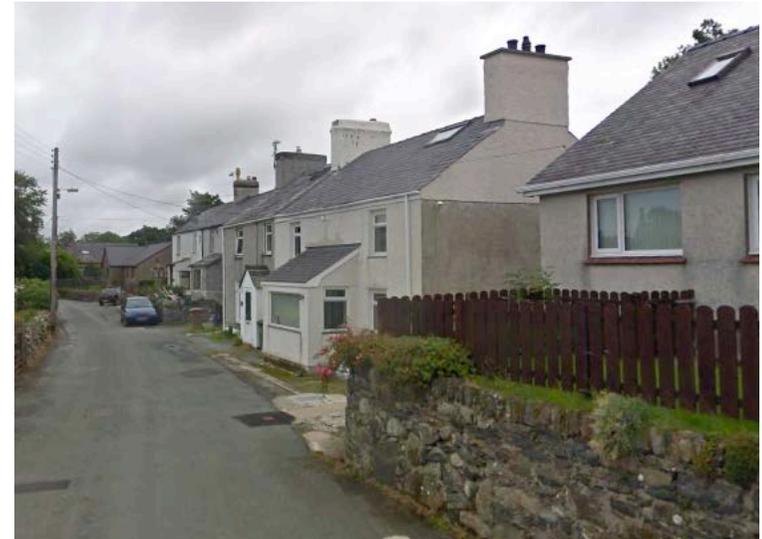
29 Modern porches, renders and uPVC windows have been installed to the detriment of the conservation area.

- 2.1.3 There are some significant issues which adversely affect the special interest of the conservation area. These include:
- The replacement of historic joinery, windows and doors with modern, generally uPVC, replacements.

- Seek to control in-fill development and development of inappropriate quality on the periphery of the conservation area.
 - Encouraging reinstatement of more appropriate joinery details to locally significant buildings, in place of modern uPVC replacements.

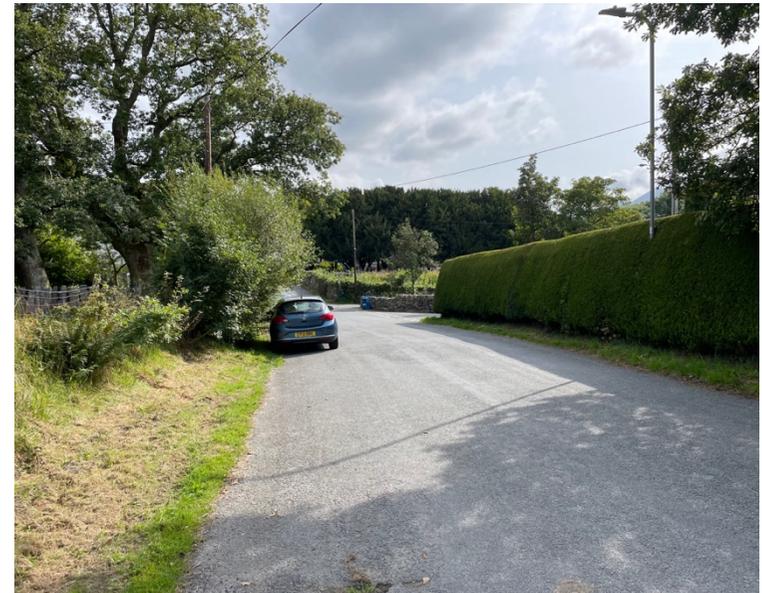
30 Leylandii and modern hedging creates a more suburban feel.

- 5.4.4 Modern leylandii and similar species have unfortunately become a regular treatment for boundaries, to the detriment of the area.
