ABERDYFI

Conservation Area Appraisal and Management Plan

Issue: 4 – Public Consultation Draft

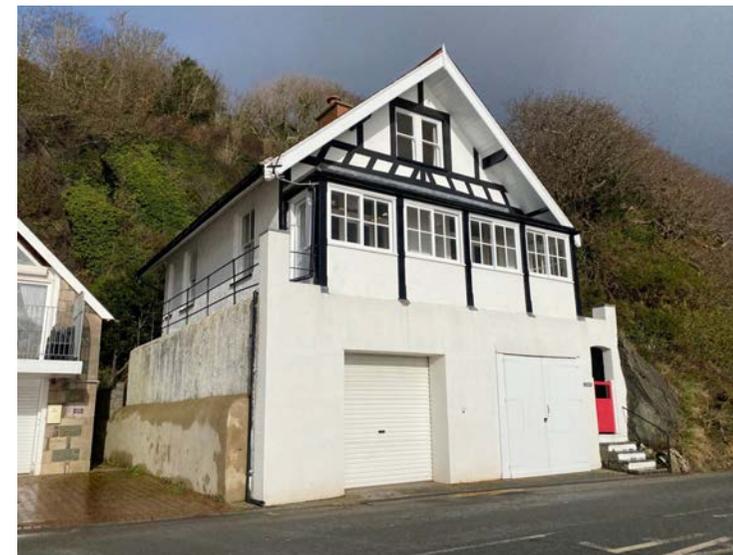
- 5.3.11 On the other side is the former lifeboat station (63) – it was reportedly built in 1886 and the slipway improved in 1903, before being closed in 1931 but re-opened in 1963 before being replaced in the 1990s. The building has timber framing to its gable and a row of multipaned casements spanning the full width of the front elevation at first floor level. The ground floor is simply used for garaging.³

25 The former lifeboat station

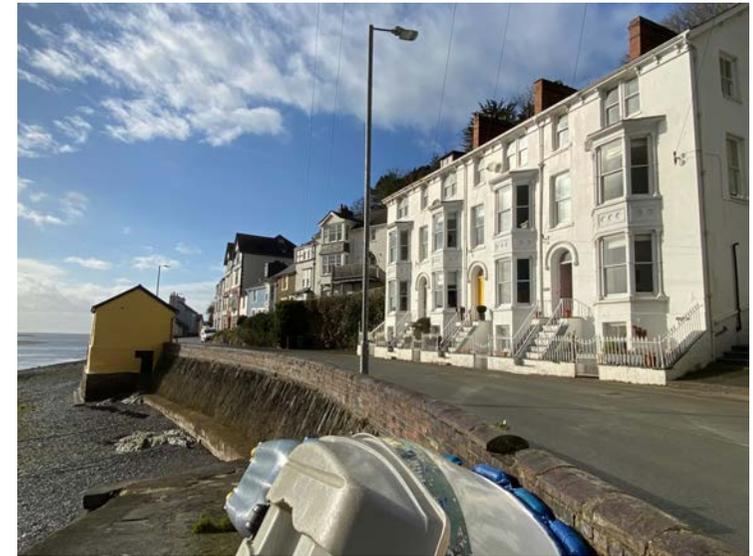
26 Cliffside in the Seaview Terrace character area with the first lifeboat house on the shore in the background

- 5.3.12 On the sea-side in an isolated position is a small, single storey building (59) – it is dated 1837 and was probably the first lifeboat house. Further down is a cluster of buildings – the first two are also single storey and of a simple nature (50-51) – these are probably from the mid nineteenth century and may have been used for fishermen. Adjacent is a contrasting and grander three bay, two storey house (Plas Dyfi, 49), with much higher proportions.

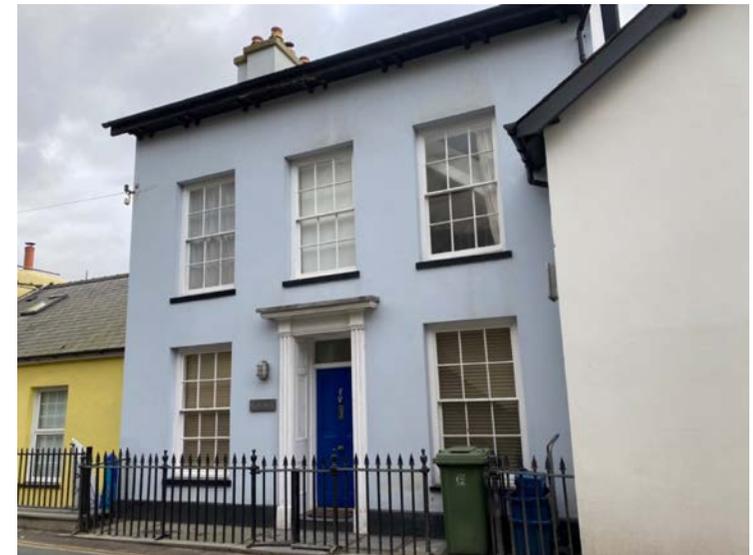
27 Plas Dyfi with a contrasting smaller dwelling adjacent

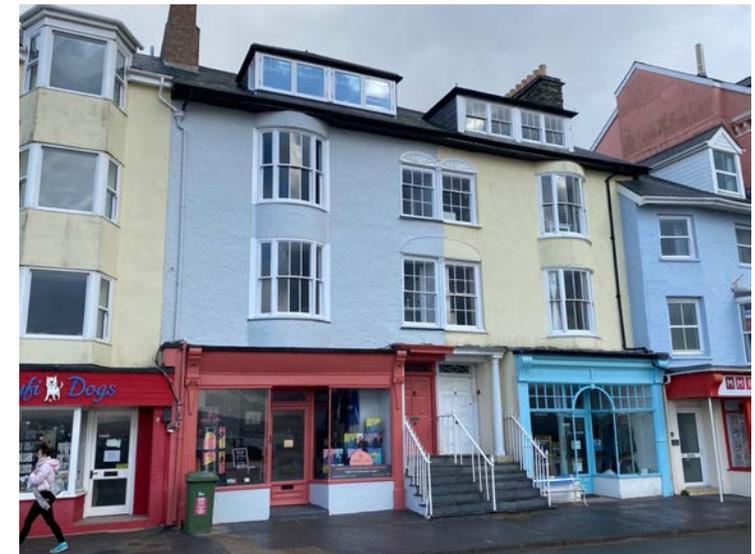
29 14-15 Glan Dovey Terrace – very unusual curved sash bay windows

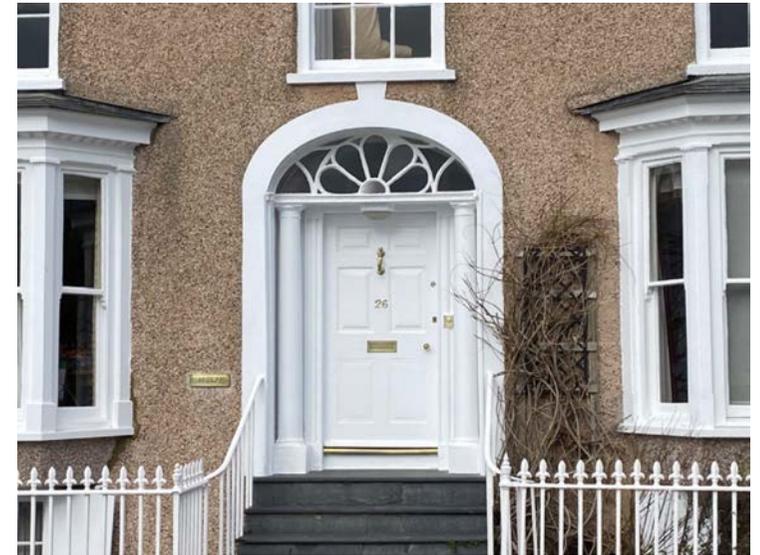
35 Doorway to house on Seaview Terrace

- 5.4.11 Doors, in particular to the seafront terraces and larger often have elaborate surrounds. Often using classical elements such as columns. A few have noteworthy fanlights. Doors to the more decorative buildings were mostly panelled, often with the upper parts glazed. The simpler buildings probably had vertically boarded doors – these are now mostly replaced due to the desirability of having some glazing.

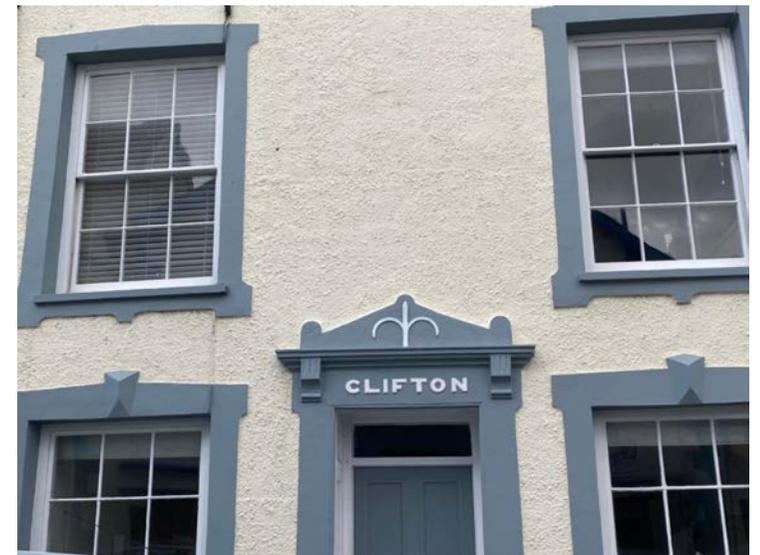
36 New Street joinery and plasterwork

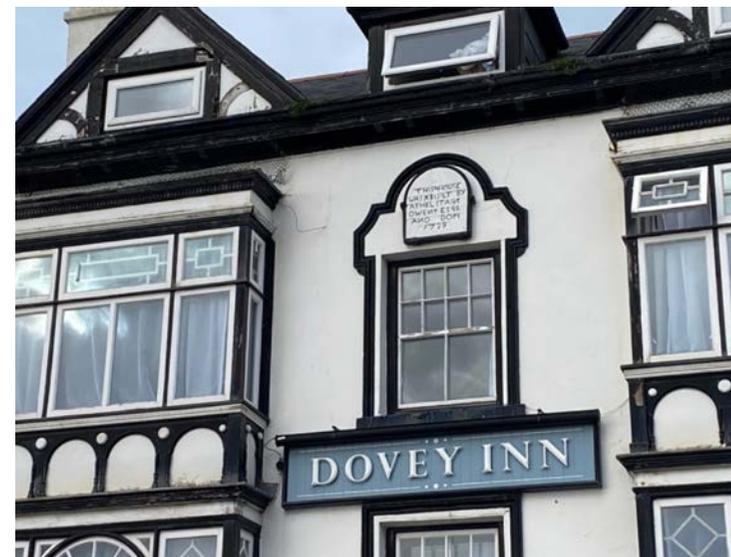
37 The decorative façade of the Dovey Inn

- 5.4.8 The sea-fronting buildings mostly have decorated facades. Bay windows are seen widely to make the most of views but also to give rhythm to the often long elevations of the terraces. Ornamental plasterwork is often seen on these bays.

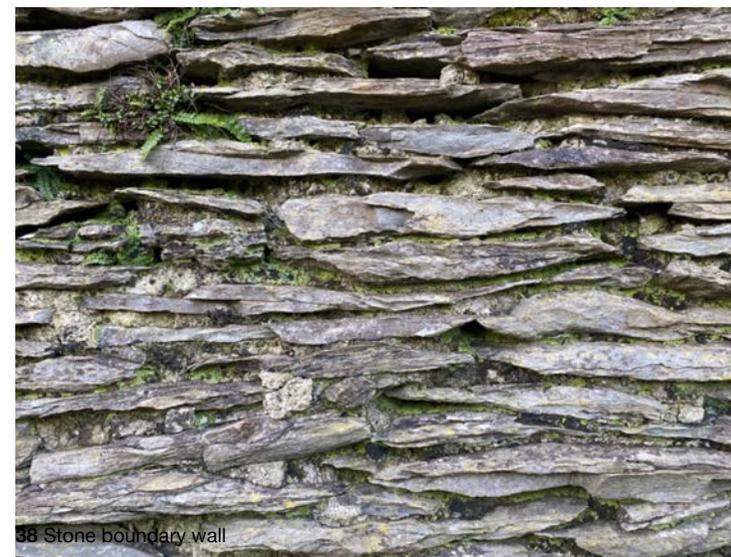
38 Stone boundary wall

- 5.5.1 Boundary treatments vary throughout the area. Along the seafront, where a building is set back it would traditionally have had a low wall (often rendered), topped with a decorate cast iron railing. A fair number of these survive.
- 5.5.2 Off the seafront, the older buildings front directly onto the roads, but there are examples of other tall and distinctive boundary walls constructed from horizontally laid, relatively thin layers of schist stone.
- 5.5.3 The late 19th century development around Hopeland Road explores the vernacular characteristics of the traditional walls and adds to their charm and unusual appearance by using thinner pieces of stone, often adding a coping where stone is laid vertically and including gateposts of various designs.

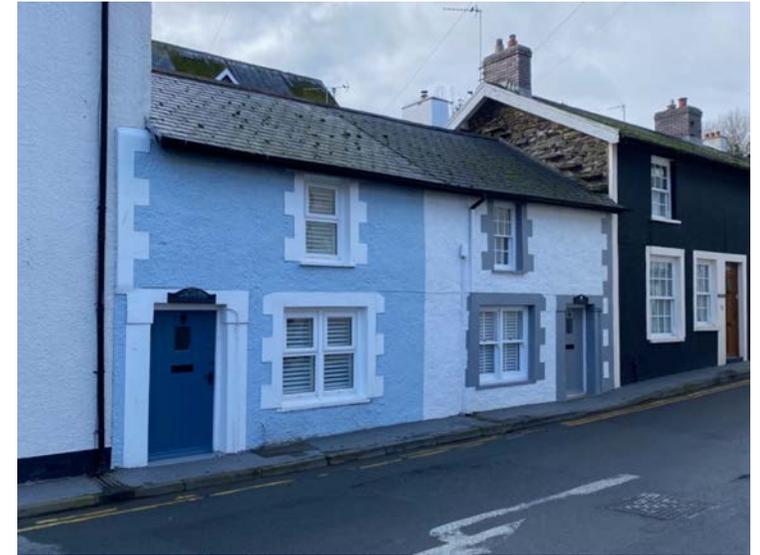
50 Potential older buildings within the Chapel Square area

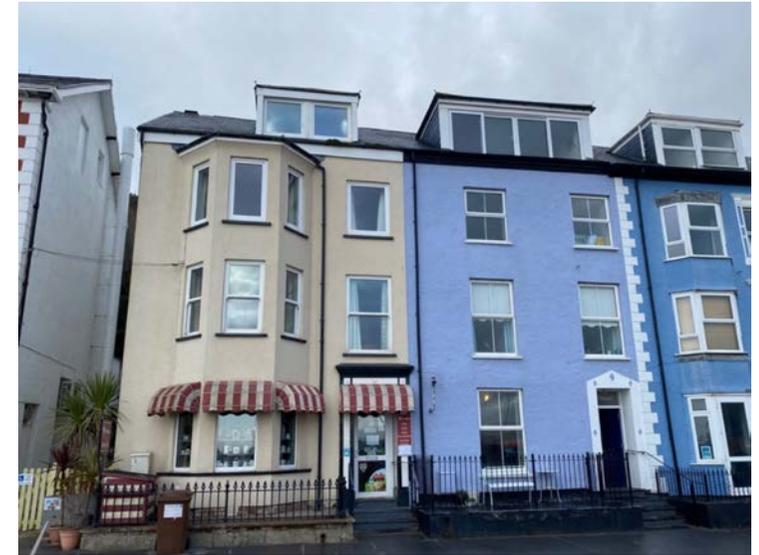
54 Glan Dovey Terrace buildings with little detail / few features remaining

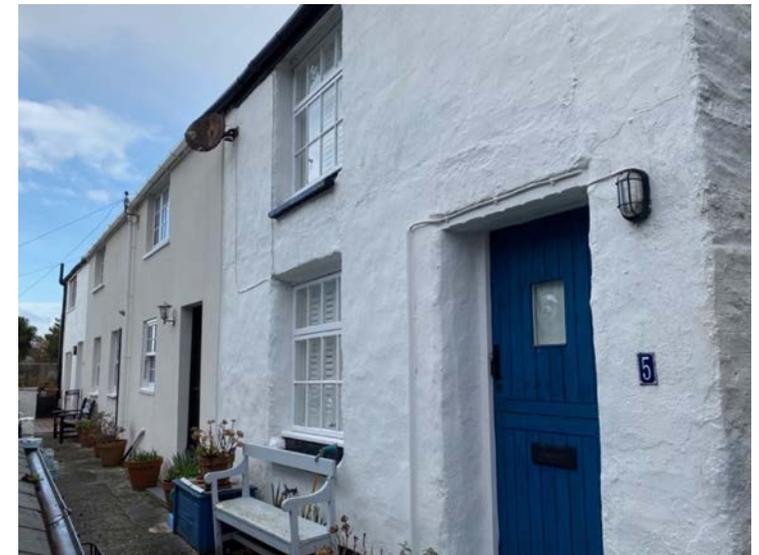
55 The impact of modern render on the appearance of the middle units of 5-8 Brynhyfryd Terrace

- The crude textured render and replacement windows of the old school / schoolhouse almost opposite the Literary Institute
- The basic modern dormers and windows of the short terrace nearly opposite the Old Lifeboat Station – the appearance is worsened by the stained pebbledashed render
- The modern render of the middle units of the 5-8 Brynhyfryd Terrace (in contrast to the older render on the end)

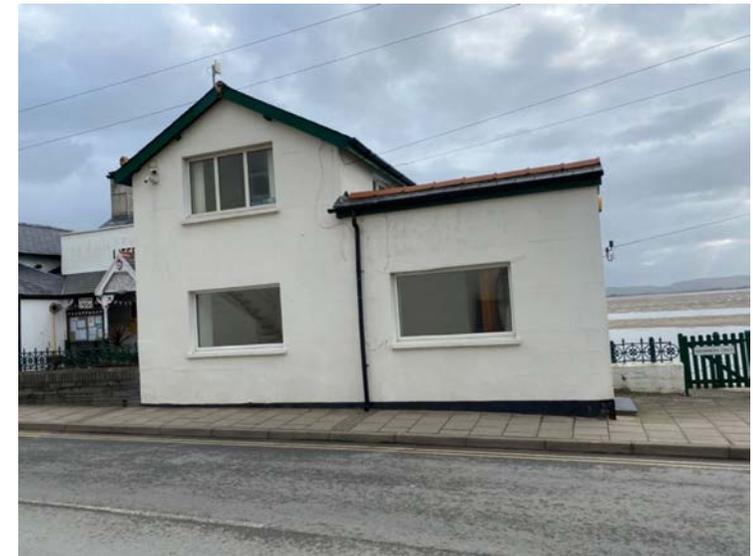
- The modern windows and (re)rendering of the wings of the Literary Institute – comparison with old photos show that its original character has been largely lost.

56 The current very basic appearance of the wing buildings of the Literary Institute

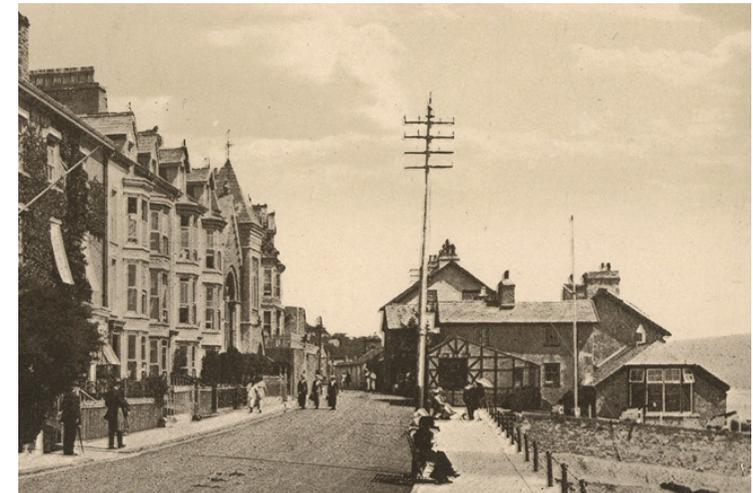
57 The Literary Institute – in contrast its previous appearance in an undated photograph – the single storey element had timber framing and both parts had traditional multipaned windows

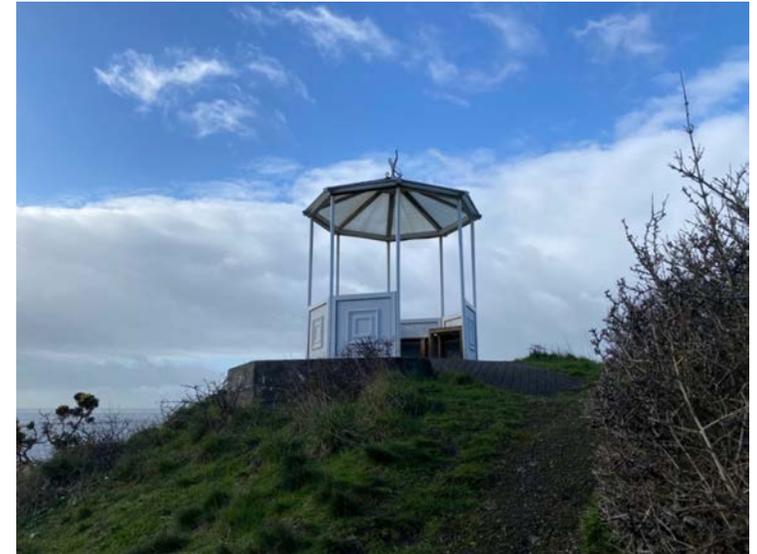
58 The basic quality of the current bandstand on Pen-y-Bryn

- Provide signage and improved access to the public viewpoints (e.g. Pen-y-Bryn) and improve their facilities such as benches, shelters and interpretation boards. In the longer-term Pen-y-Bryn would benefit from a more appropriate replacement to its bandstand

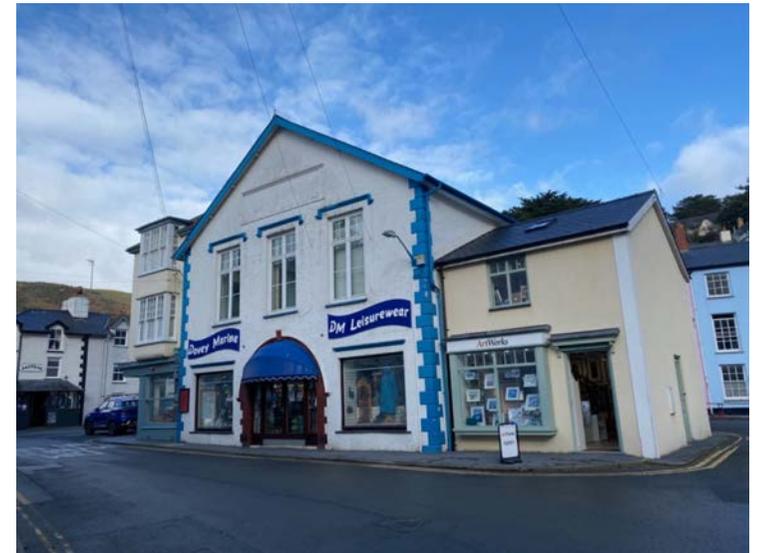
59 The town would benefit from more information on historic buildings such as the Imperial Hall

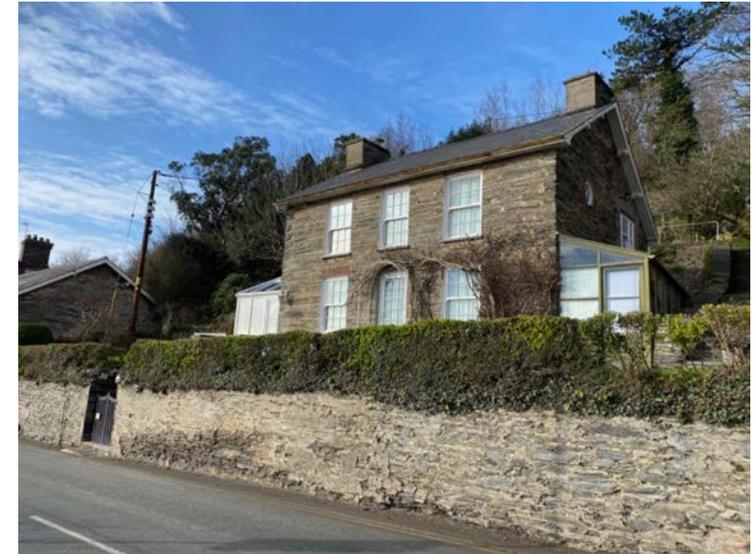
60 It is proposed to extend the conservation area boundary to include a short run of buildings in Penhelyg – it would take in Tanyrallt

existing conservation area along Penhelig Road. This will include Tanyrallt, a three-bay, two storey detached house, which is in good, original condition and provides a picturesque gateway to Penhelyg and Aberdyfi beyond. Old OS maps indicate that this may have once been a police station. This area would probably be added to the Penhelyg character area.

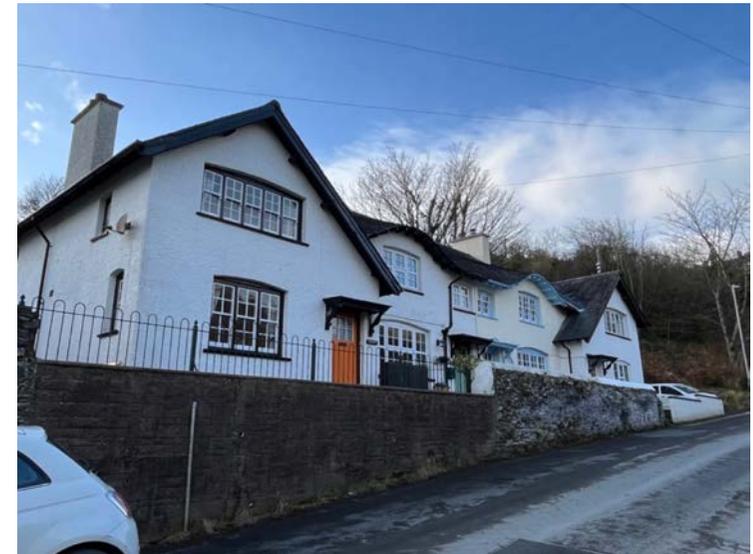
61 It is proposed to extend the conservation area boundary to include buildings on the upper section of Copperhill Street

- It is also recommended that the area is extended to include the area of Copperhill Street beyond the railway. This relatively small area will encompass a good number of the 19th century buildings previously excluded and incorporate some more of the hillside that features in the immediate backdrop of views of the town from the coast. These buildings have much of the special interest of other buildings in the town and have a good level of surviving features. This area would warrant its own character area.

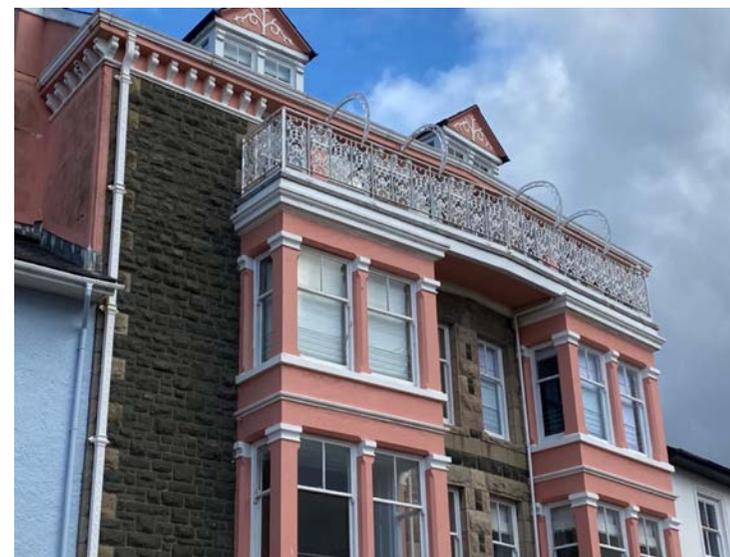
62 Westhaven has a very high level of architectural detail remaining – inclusion on the national list may be beneficial

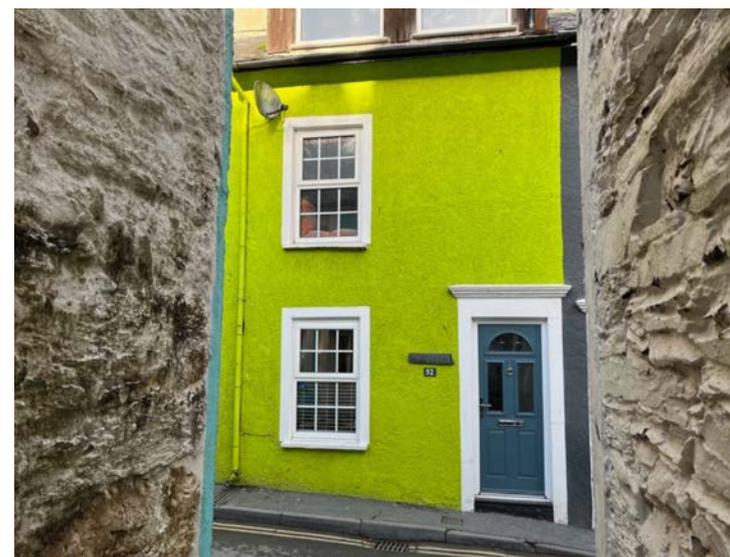
63 A design guide should advise on the suitability of colours within the conservation area

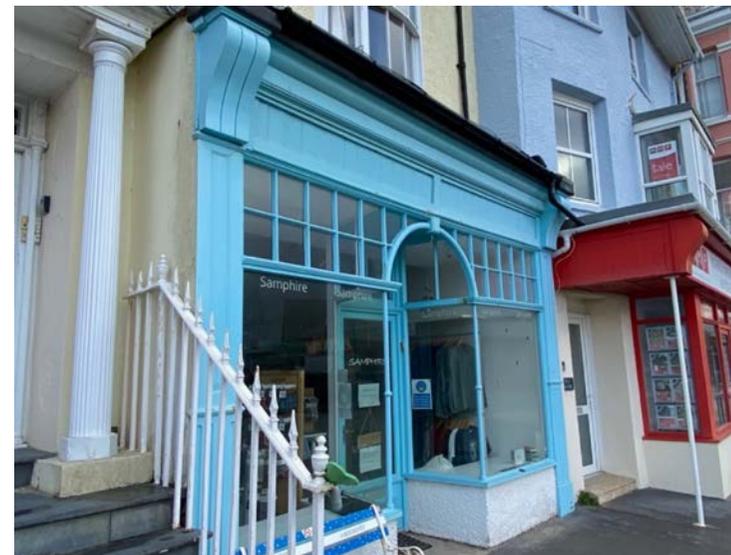
64 A traditional shopfront on Glan Dovey Terrace

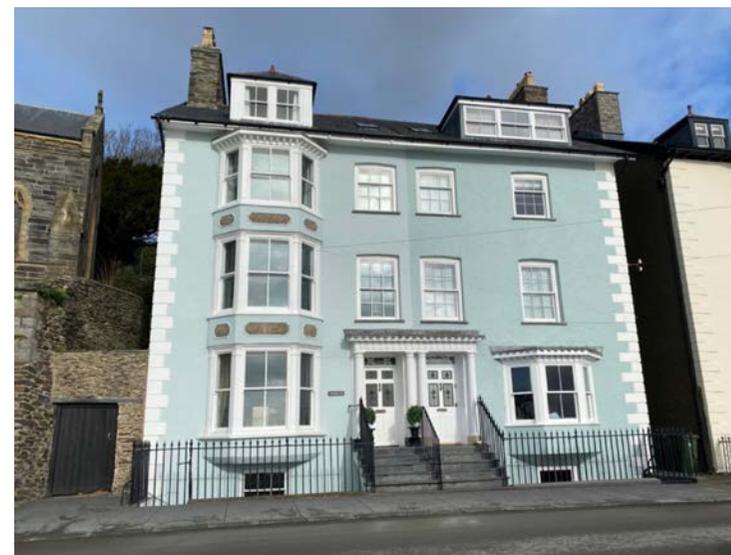
65 A Seaview Terrace semi-detached pair
