ABERGWYNGREGYN

Conservation Area Appraisal and Management Plan
Chambers Conservation Ltd.

Issues: - Public Consultation Draft

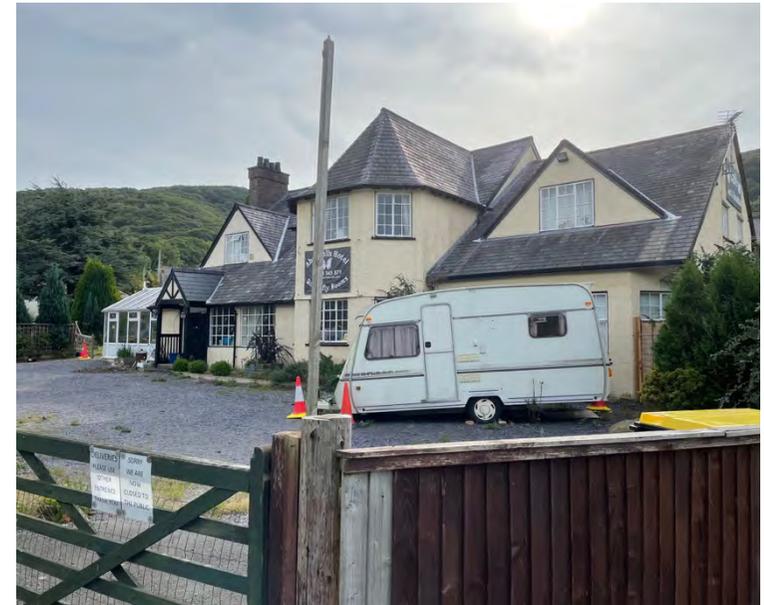
- 5.2.2 The architectural character at the north of the conservation area reflects the developing importance of the east-west road in the early 20th century. The Aber Falls Hotel epitomises the interest in traditional building forms which accompanied 'roadhouse' architecture of the 1930s. The hotel is a well preserved example retaining original crittall-type windows and largely unaltered. Sadly the original corrugated garage adjacent has been lost, its later replacement has now been turned into a café/ice cream parlour. To the south-east of the hotel, the original Café Royal, now a bungalow, of similar period and detailing as the Falls hotel, retaining a wide crittall-type steel window.

19 Aber Falls Hotel (formerly Halt), retaining original steel windows (2021).

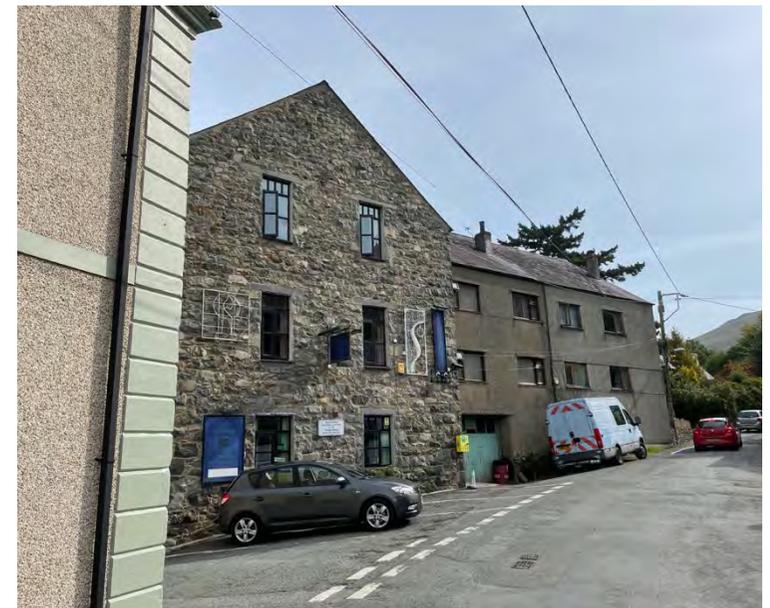
5.2.7 Aber Mill is predominantly 19th century, but heavily altered. The northern wing, of rubble stone, with slate (or slate faced) lintels, is now operated as a community facility with café and visitor centre on the ground floor. Windows

22 Hen Felin. (2021).

are modern, all below a Penrhyn slate roof. There is a modern, slate hung, extension to the north. The wing to the south is rendered in poor quality pebble-dash, with uPVC windows, with slate roof over. The scale of the mill, in particular, is important, bringing a clear link to the role of industry in the history of Aber.

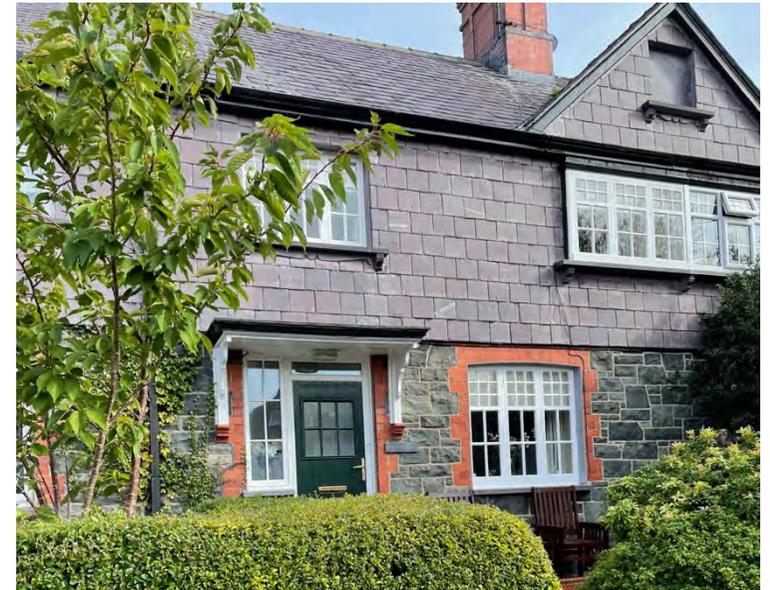
25 Rubble, brick dressings and hung slate, Glydfan (2021).

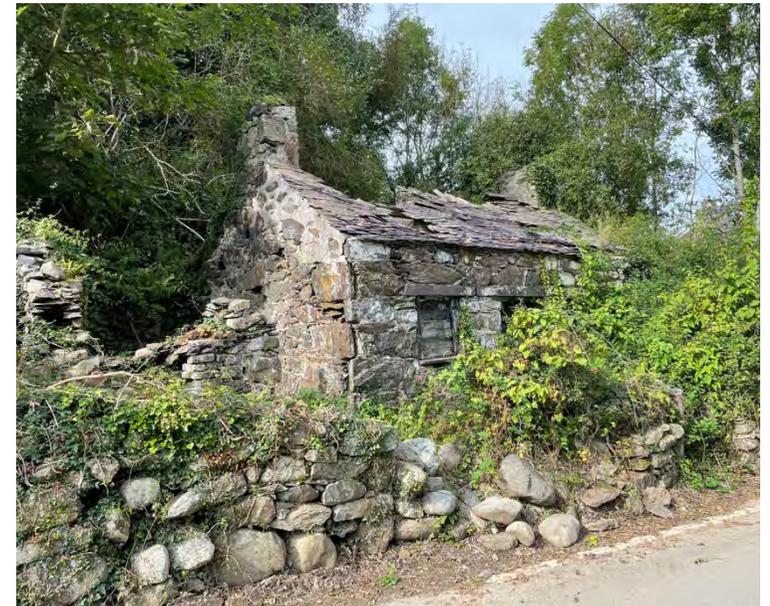
26 Field stones in the early wall to Ty'n Ffridd. (2021).

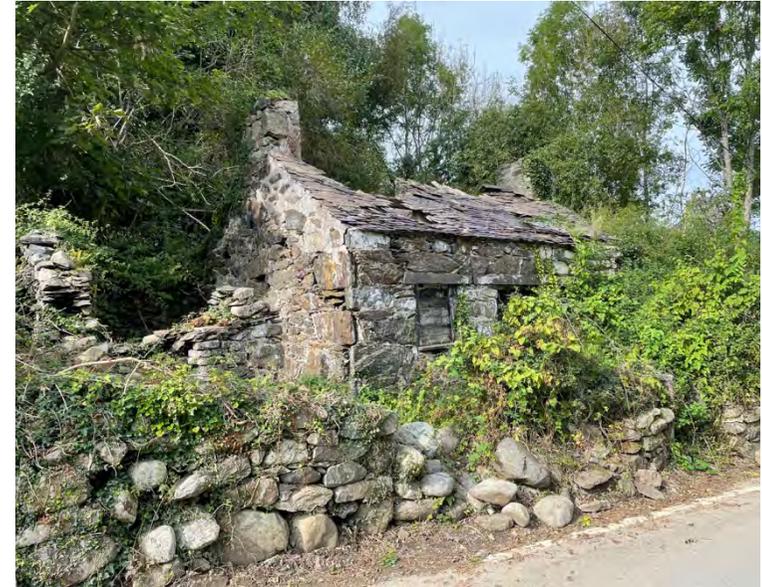
- Ty'n Fridd, a listed building south of the village centre is derelict and in a poor condition.
- St. Bodfan's church is not listed, but a prominent and important building. It is understood this is currently used for storage. It is, however, deteriorating and this isn't an appropriate long term use.
- The building on the corner of Gadlys and Bryn Tirion, which has a shop (un-used) and is a building of fine proportion and potential.
- The 'non-community' part of the mill which is delapidated and untidy and rendered in modern pebble-dash. It is very prominent especially when approaching from the south.
- At the time of the fieldwork for this report, the Falls Hotel not operational. Change to domestic accommodation would be damaging for the village and the area.

31 Ty'n Fridd, a listed building in a very poor state and highly at risk.

- Find a suitable new uses for Ty'n Ffridd and St. Bodfan's Church.
- Seek to enhance the appearance of some of the other key buildings, e.g. Hen Felin (south wing), Capel Soar (primarily the windows) and other key windows.
- Build upon the excellent work in developing sustainable energy generation in Aber, which could be a benchmark for other villages in this regard.
- Potential to enable access to the Mwd, and provide better interpretation, building on that provided in the Ty Pwmp.
- Consider enhanced pedestrian connections to the falls.

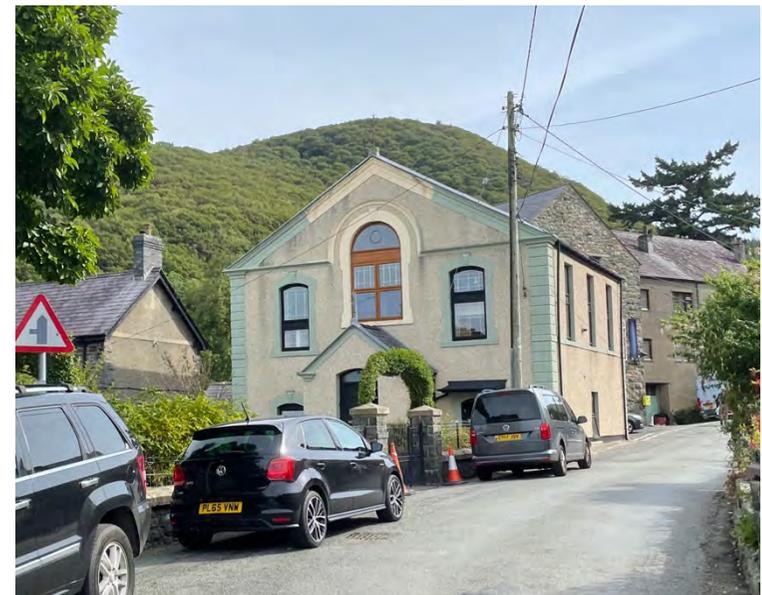
- The replacement of historic joinery, windows and doors with modern, generally uPVC, replacements.
- Application of modern renders and paints externally.
- Inappropriate or poor quality developments or extensions.

32 Modern uPVC windows have had a detrimental impact on the character of the village. The modern windows of Capel Soar are particularly prominent.

- Replacement of windows and doors to key buildings in the conservation area including Capel Soar, parts of Hen Felin and most of the non-listed houses.
- Render to the southern part of Hen Felin and to many of the 19th century houses.
- The new uses (café and ice cream parlour) for the former garage to the Falls Hotel is positive, but the changes (cladding etc) are very prominent visually at the entrance to the village.

- Seek to control in-fill development and development of inappropriate quality on the periphery of the conservation area.
- Encouraging reinstatement of more appropriate joinery details to locally significant buildings, in place of modern uPVC replacements.

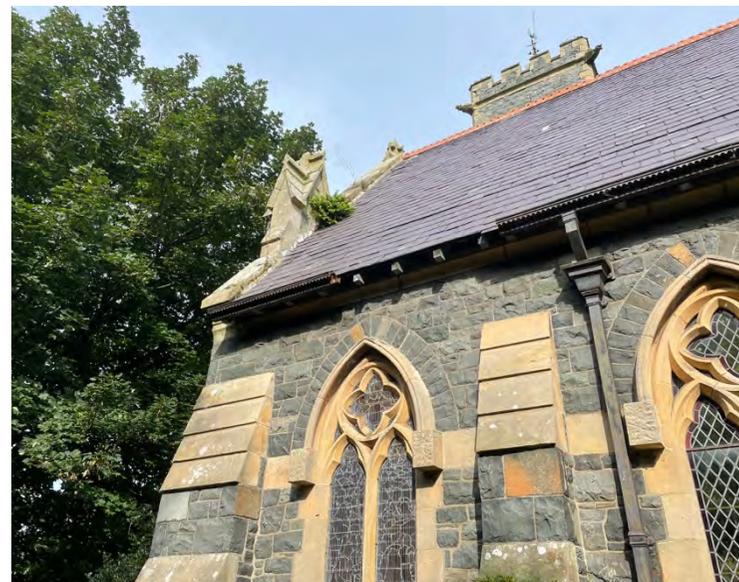
2.2.2 St. Bodfan's church is not listed currently (although this is recommended for review in this report) and no-longer a place of worship. It is understood it is currently in use as storage, but its condition is deteriorating.

33 Missing rainwater goods and plant growth to copings. St. Bodfan's Church.

- 3.2.2 As noted in 6.1 of the CAA, it is recommended that St. Bodfan’s Church and the Aber Falls Hotel are considered for listing. If this is not possible they should be protected by article 4 directions.

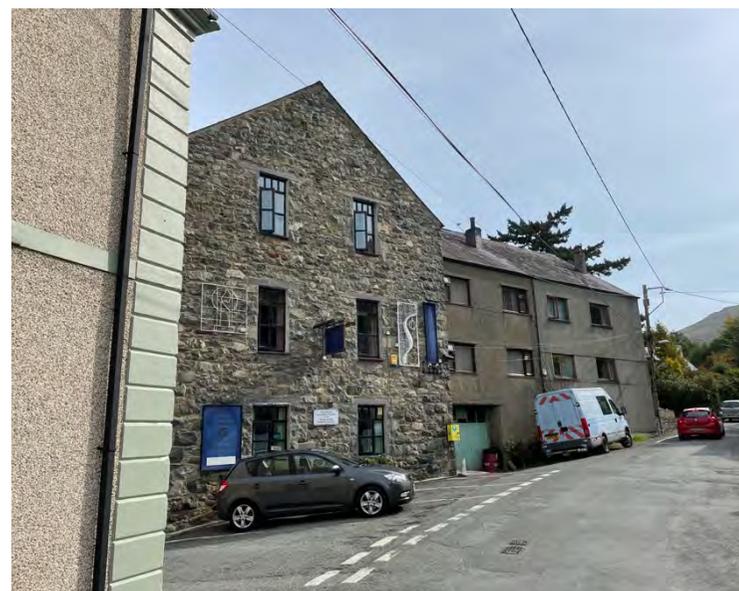
34 Hen Felin, community element (to the left, unrendered) and residential element to the right (rendered in modern pebbledash).
