ABATY CYMER

Conservation Area Appraisal and Management Plan
Chambers Conservation Ltd.

Issues: - Public Consultation Draft

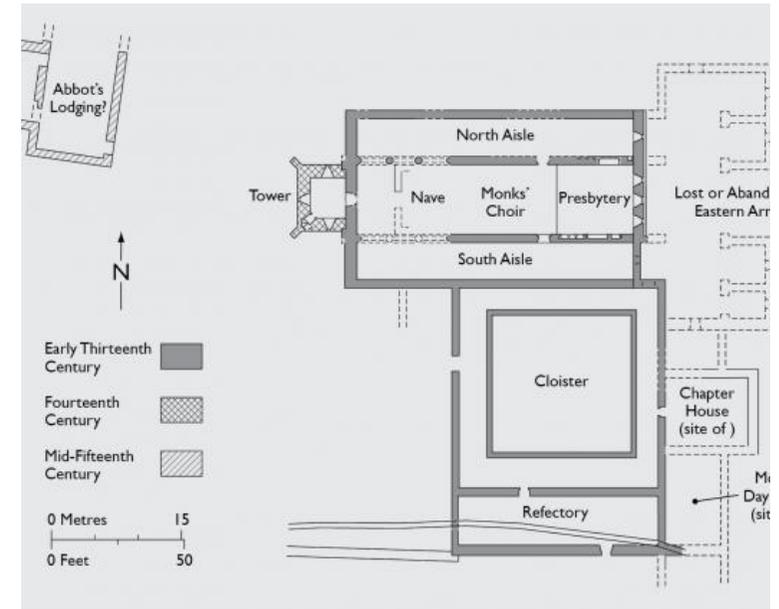
11 Dating Plan, Abaty Cymer (Cadw).

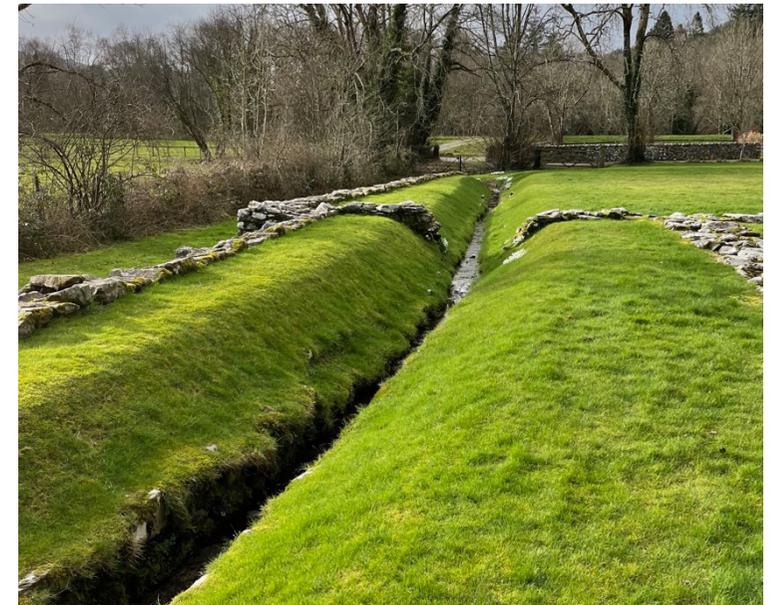
13 The Refectory, built over a watercourse, looking west (2022).

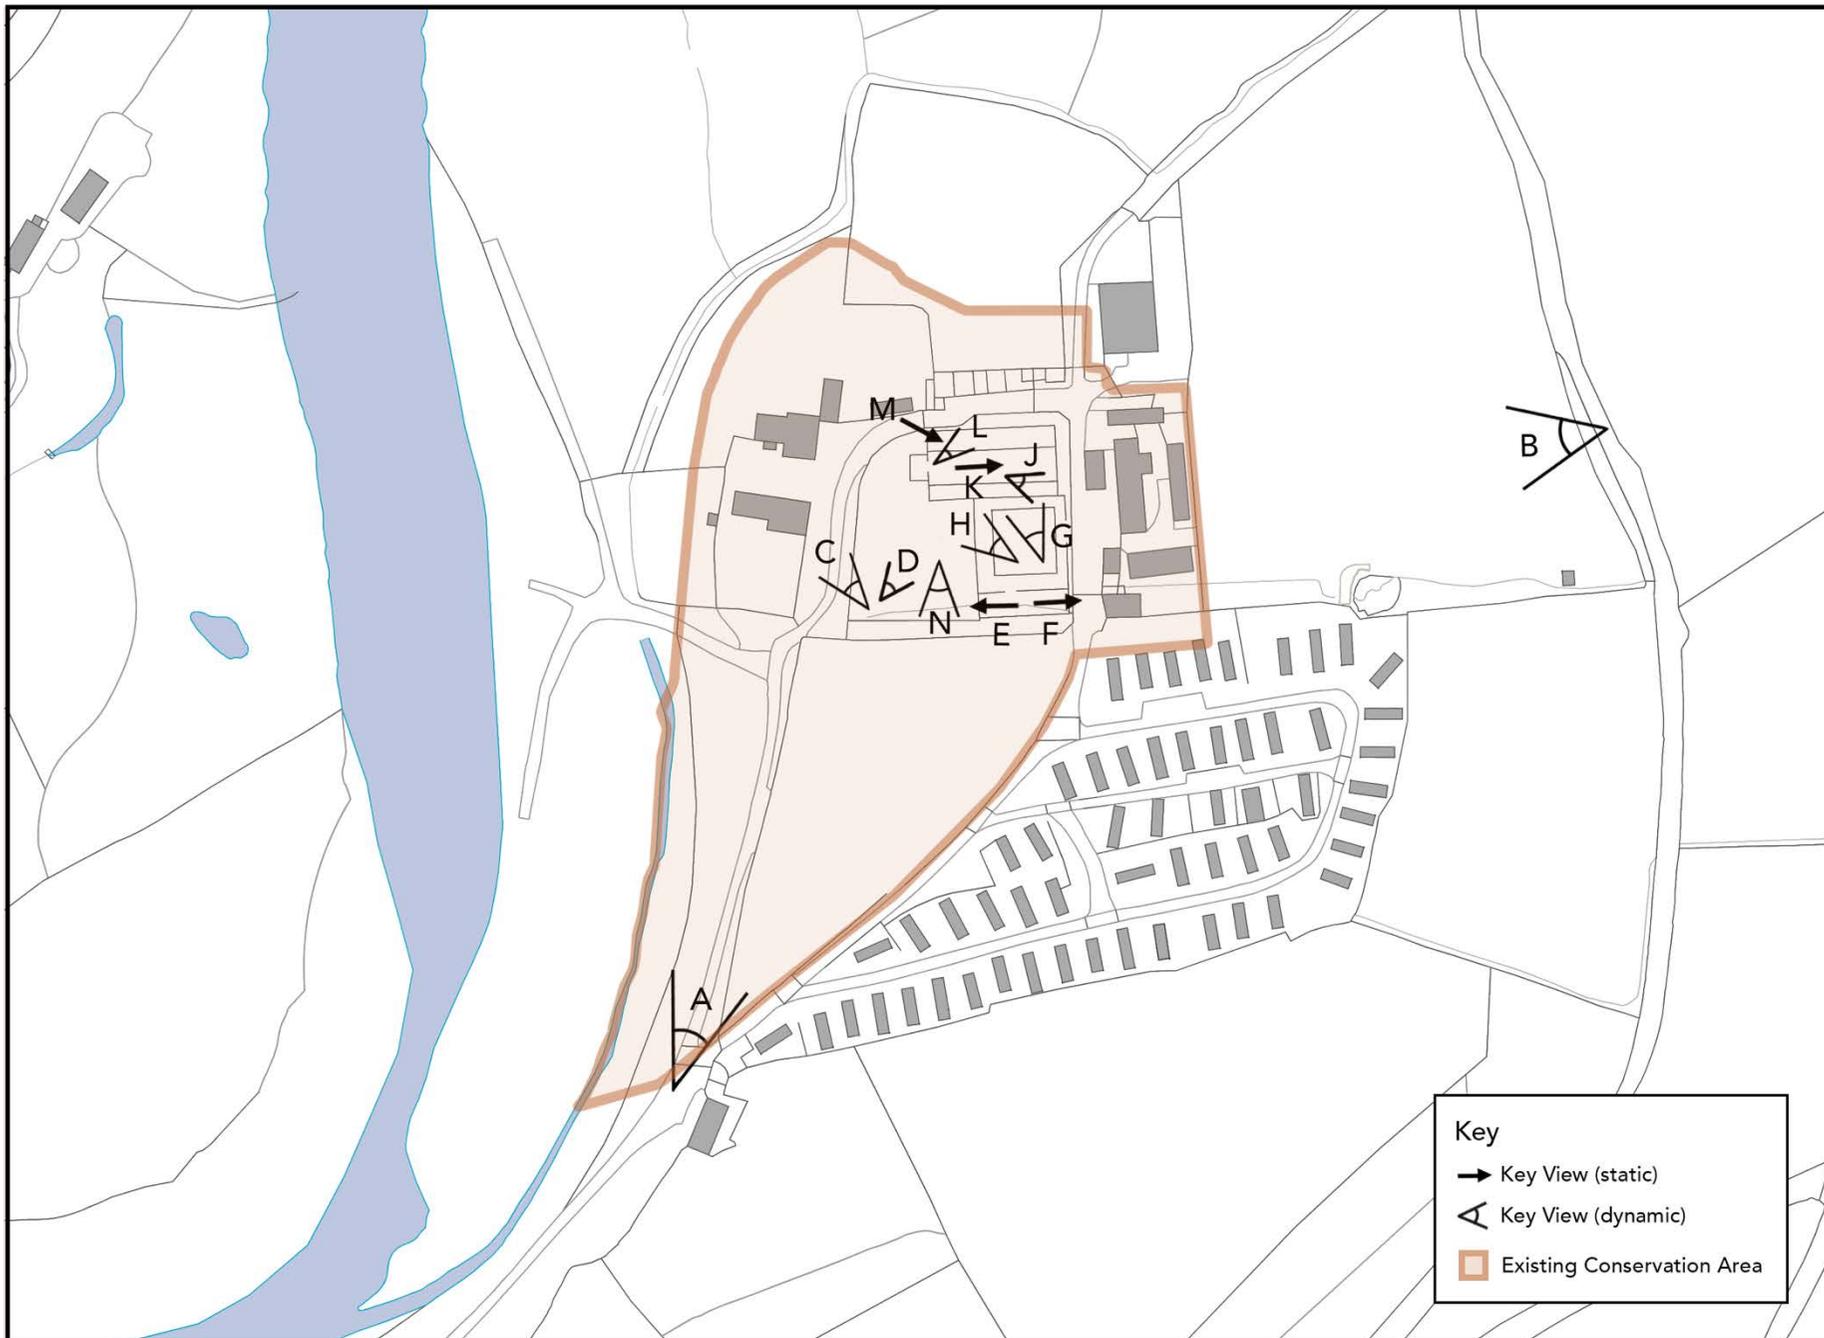
Key Views
1:2000 @ A4

4.2.3 These are as follows (see Fig 15):

A Dynamic view towards the abbey from the gated entrance to the caravan park.

B Glimpsed views from the lane above the abbey across the field.

C Dynamic views towards the Abbots Lodgings/Farm House and adjacent range.

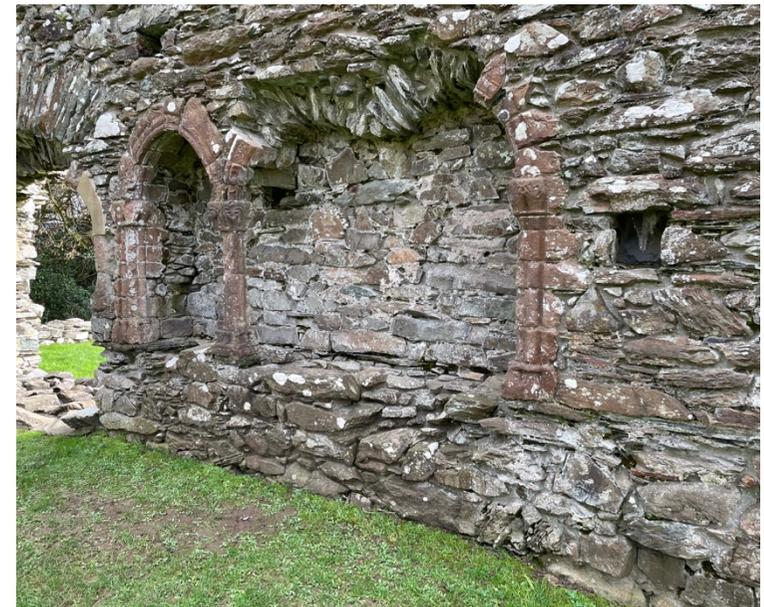
18 The sedilia and door way to the south (2022).

- 5.2.5 To the south-wall there is a sedilia with three bays, retaining sandstone arches, pedestals and single column. The sandstone is now quite heavily weathered. Adjacent is a potential tomb recess and piscina. Adjacent is a arched doorway, which has undergone significant indent repairs to the head. To the north-wall there is a further recess, again perhaps for a tomb.

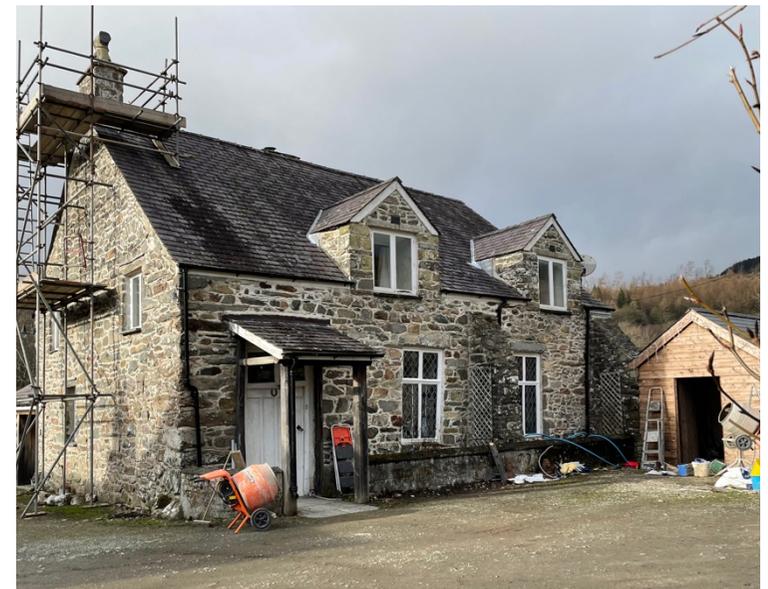
22 Ty Fanner (2022).

5.3.4 The windows on the ground floor, east front of Ty Fanner are mullioned timber and could be of 17th century origin. The door adjacent is probably of similar date, wide boarded with raised and profiled frame.

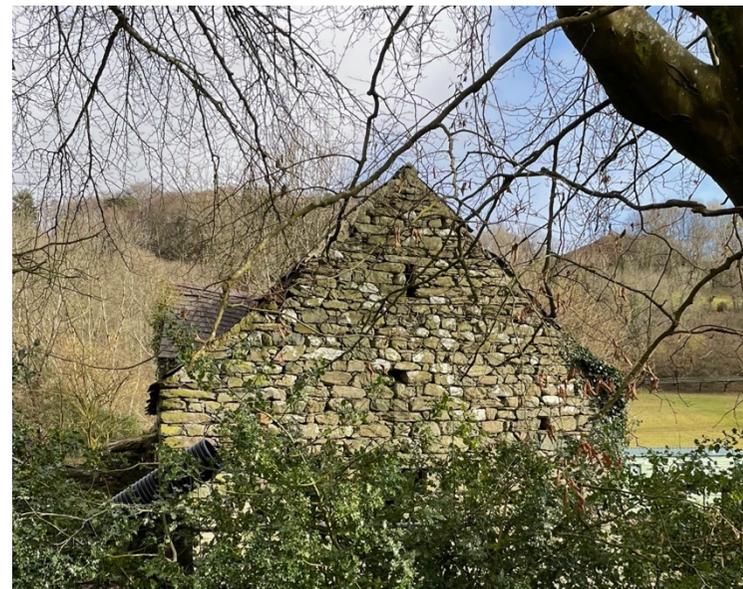
- 5.2.13 The farm buildings east of the abbey ruins include a mid to late sixteenth century barn, later extended and a late seventeenth century byre. The latter is now in poor condition with failure in the roof evident to the north.

23 The byre from the precinct (2022).

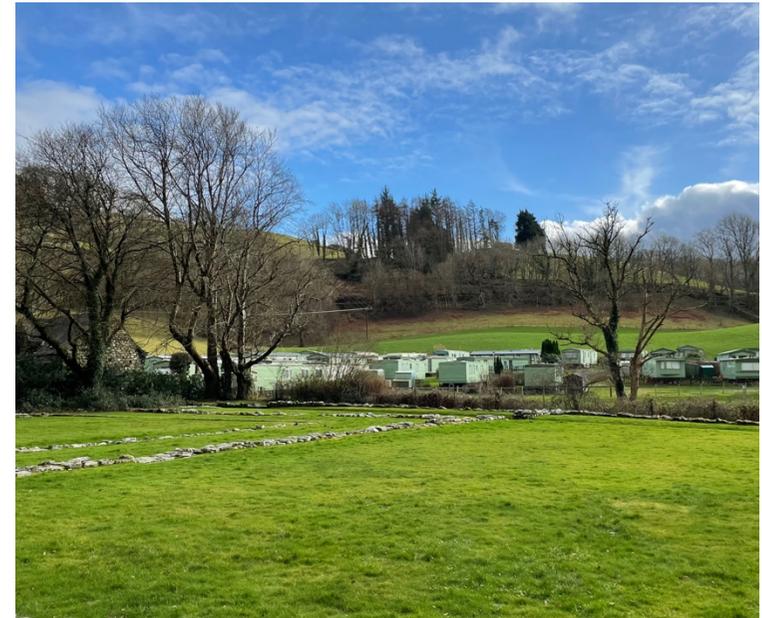
- Condition of some of the buildings.
- 2.1.6 Specific examples include:
- Change of caravan park from a touring park in the 1950s (see fig 26) to a park with significant numbers of static caravans (see fig 32) and associated developments.

- Consequent impact on views to and from the abbey.
 - Some of the surfacing in the immediate context of the scheduled area.
 - Condition of the byre which appears to be deteriorating.

32 The caravan park affects the setting of the Abbey ruins. (2022)

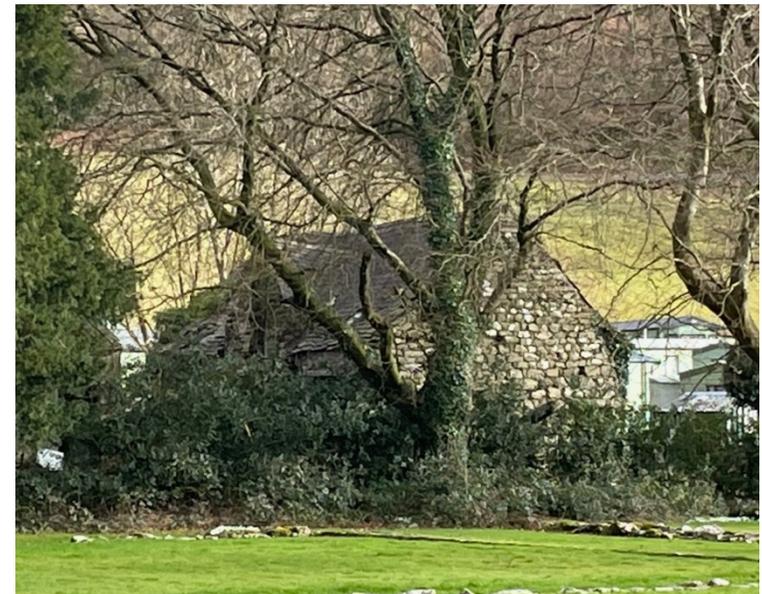
- 2.1.3 The caravan site is well maintained but still has a negative impact upon the setting of the abbey.
- 2.1.4 Most of the buildings would appear to be in beneficial use, however the byre (listed grade II) is starting to deteriorate and is in need of conservation and repair.

- 2.2.1 The byre (grade II) is currently deteriorating, the roof to the north in particular.

33 The condition of the listed byre, east of the precinct is of concern. (2022)

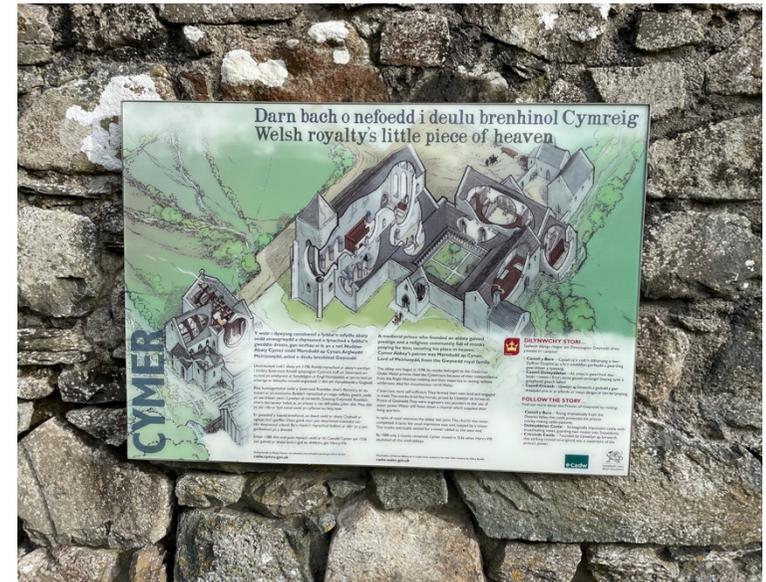
34 Interpretation on the site is limited and could be significantly enhanced (2022).

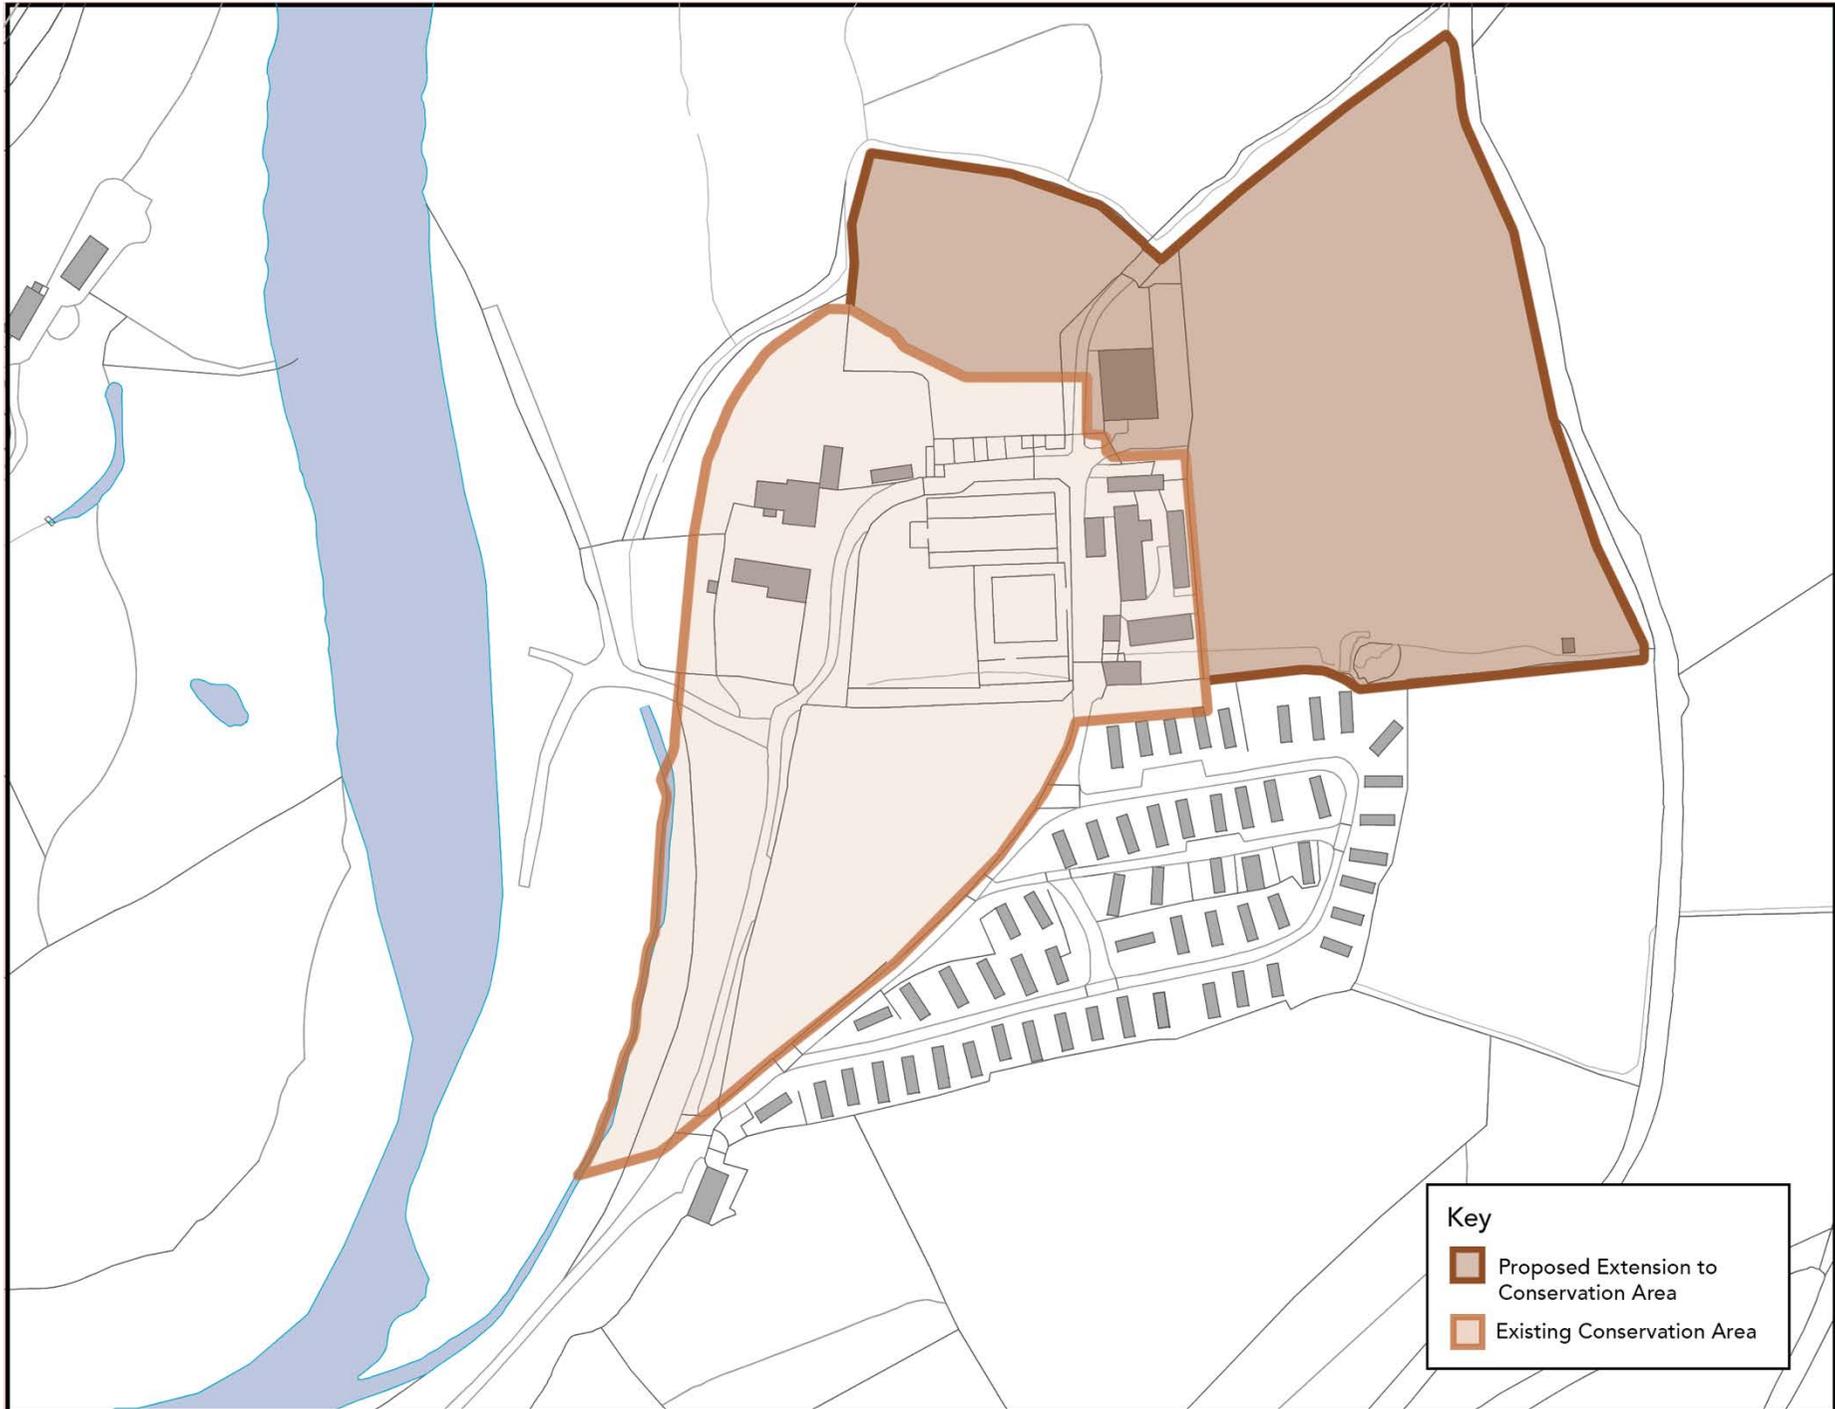
Proposed Extension to Conservation Area

3.1.1 Following the appraisal, it is recommended that the boundary be extended to protect the setting and potential monastic cemetery and orchard (to the north and east). See Fig 35.
