DOLBENMAEN

Conservation Area Appraisal and Management Plan

Chambers Conservation Ltd.

Issues: - 4 Final Draft for Public Consutation

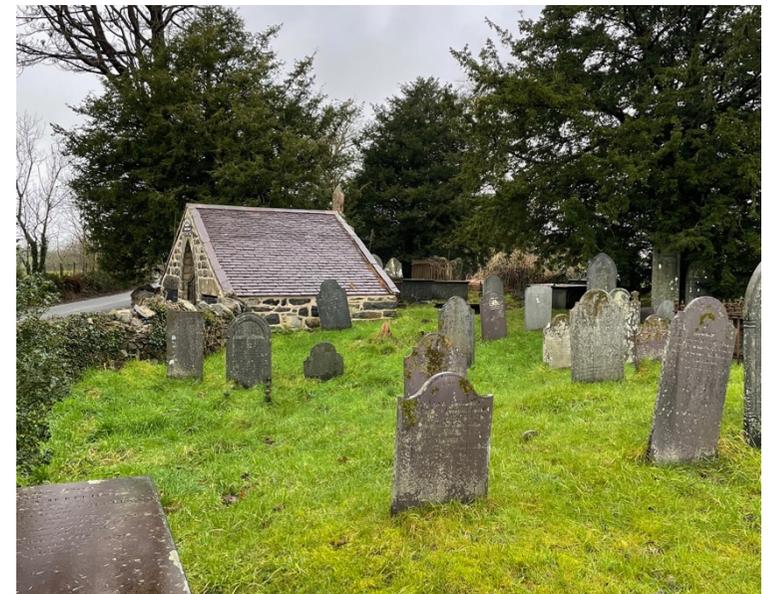
06 Diminishing coursed slate roof to the lych gate, with long stone copings (NB this is a new roof, replaced within the last 5 years or so. (2021).

- 5.2.10 The roof of the lychgate has been recently repaired, and the whole repointed, retaining thicker diminishing coursed slates and substantial stone copings.

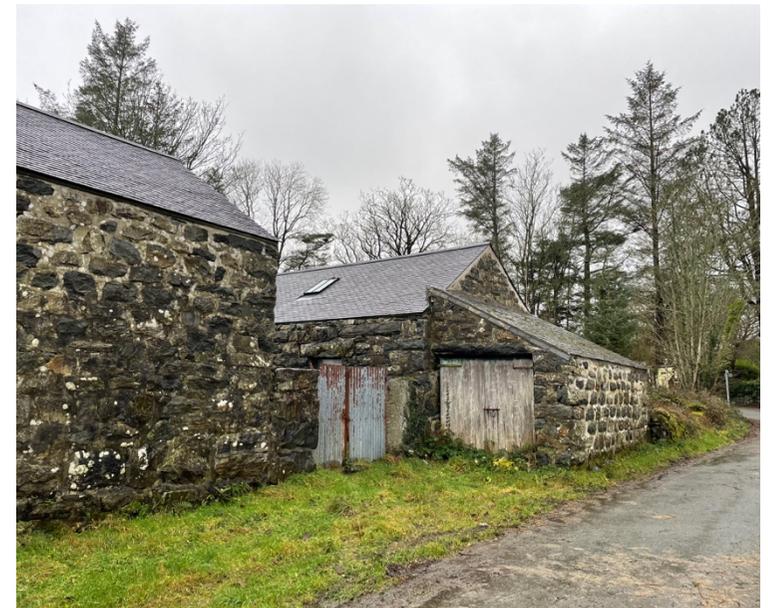
12 Listed outbuildings of Plas Dolbenmaen – note modern roofs. (2021).

- 5.2.6 The outbuildings have been re-roofed in machine-cut slate, which lacks character in comparison to earlier slating visible in photos retained by RCAHMW. It is not clear whether the original detail referred to in the listing is retained internally.

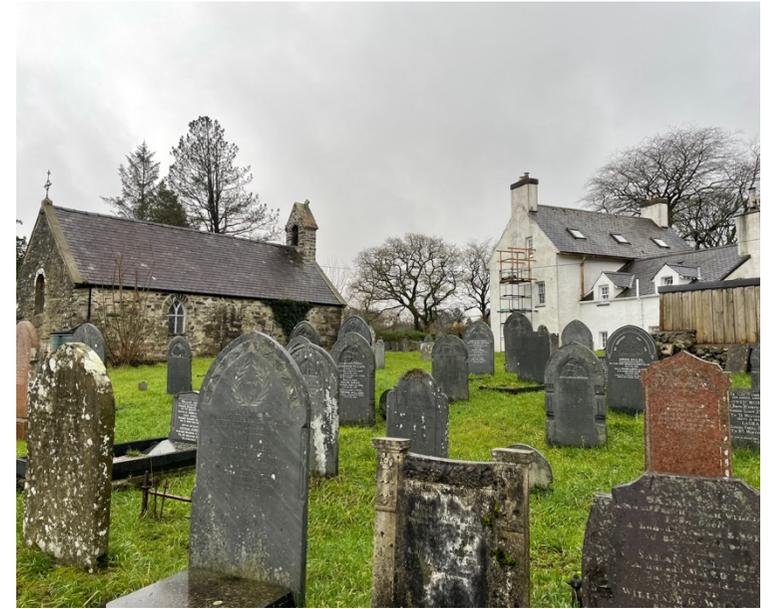
23 Church and Plas Holland. Earlier range to the rear of Plas Holland, note visually disruptive outbuilding (right). (2021).

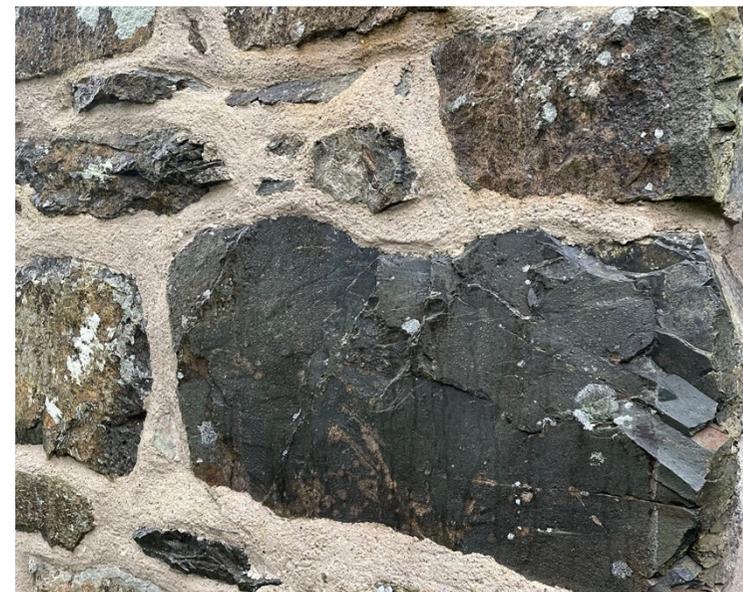
26 Fine-grained igneous rocks to the Lych Gate, recently repointed (2021).

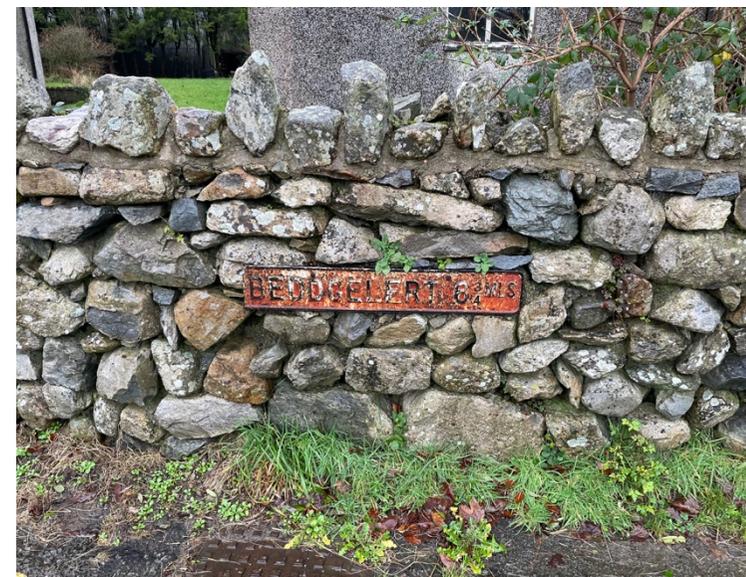
28 Dry-stone walling (although with mortar bedded coping) and cast iron signage outside Ty Canol. (2021).

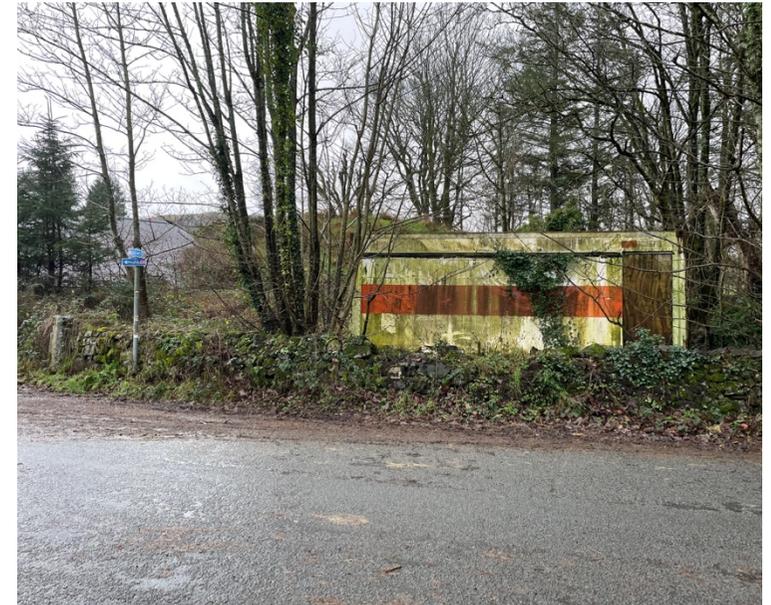
30 Storage container adversely affects the setting of the Mwd. (2021).

- 5.2.3 The road widens outside the 19th century Lychgate which lifts the status of the junction. Views to the Mwd are somewhat overgrown and are partly obscured by a large storage container, but the visual relationship is still a strong one.

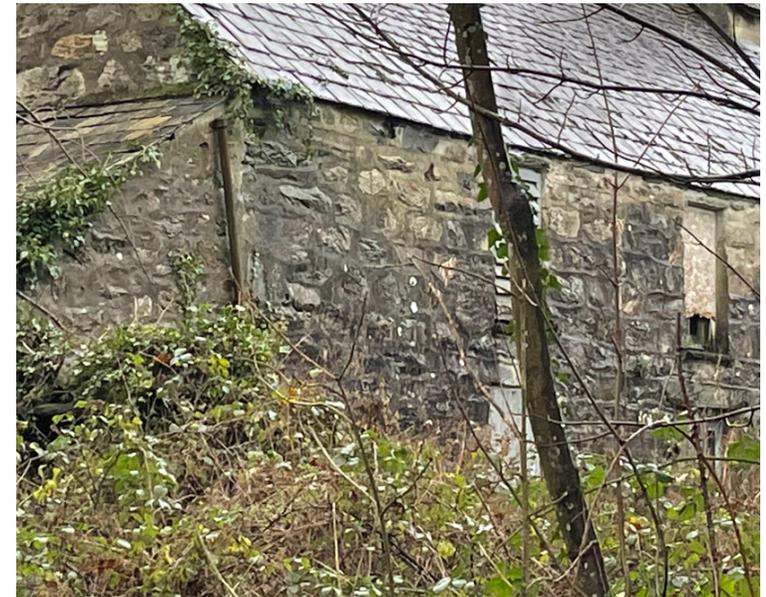
35 Cement pointing, Plas Dolbenmaen.

- Modern cement pointing to Plas Dolbenmaen and St. Mary's Church.
- Modern render to Plas Holland.
- Outbuilding adjacent to the churchyard at Plas Holland.
- Modern paint finishes over stonework and metal extension to Min-y-Ddol.
- Development of Ty Canol (including the replacement of the house), extensive surfacing and modern storage buildings.

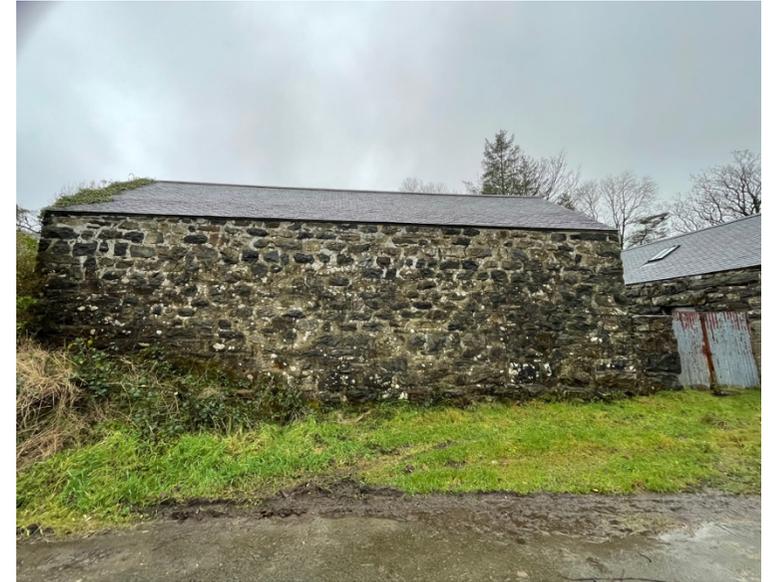
36 NE range of buildings at Plas Dolbenmaen (probably formerly stabling), note the relatively new slate roof. (2021).

- 2.2.1 Plas Dolbenmaen and the associated, listed, outbuildings are not in use. This puts these buildings and the Mwd, which are linked, significantly at risk.
- 2.2.2 As previously noted, applications were approved by Gwynedd Council for the conversion of the outbuildings to a cycling centre and café in 2005 and works would appear to have commenced on this, including replacement slate roofs (modern, even courses) but ceased. Planning and Listed building consent for the retention of Plas Dolbenmaen as a house, with associated modifications were approved in 2012, but no works have been undertaken.
- 2.2.3 If no works are forthcoming in the near future, the local authority (as this lies without the National Park) should *urgently* consider taking further action.

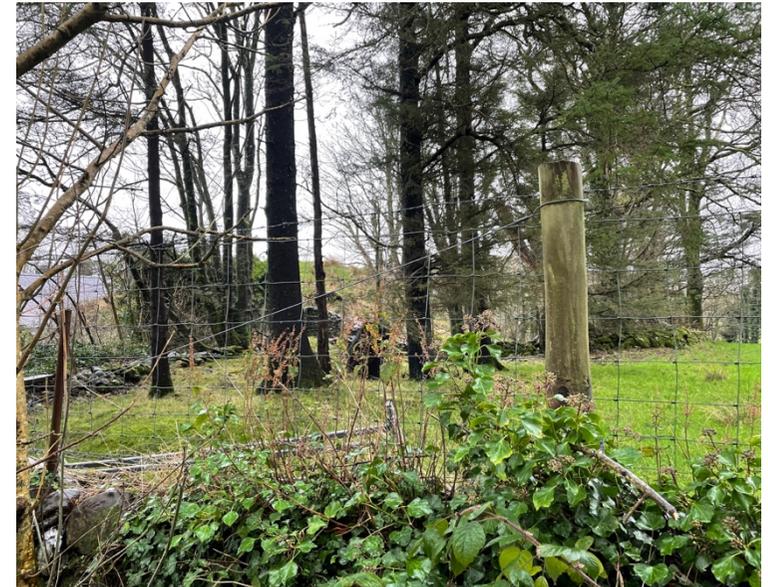
- Lack of visibility of the mound, concealed from views, especially when trees are in leaf.
- Loss of original house at Ty Canol.
- Yard and large metal buildings at Ty Canol.
- Loss of key views through later tree and scrub growth.
- Lack of use of former road across Pont Dolbenmaen - consequent poor condition.
- Proximity and traffic noise from the A487.

37 Views of the Mwd from the village are largely concealed by trees and scrub growth, some now starting to affect the mound. (2021)

- Better control development and change in and around the Conservation Area to ensure they better reflect the local materials and are of appropriate quality, layout and design.
- Extend conservation area boundary to include the Bungalow.
- Open up views to the Mwd, by removal of scrub and less significant trees.
- Consider enhanced interpretation and work with landowner for potential access to the Mwd.
